Erosion from Sinkhole Closes State Route 35 In Rural San Mateo County

Updated March 18, 2019

Updated February 25, 2019

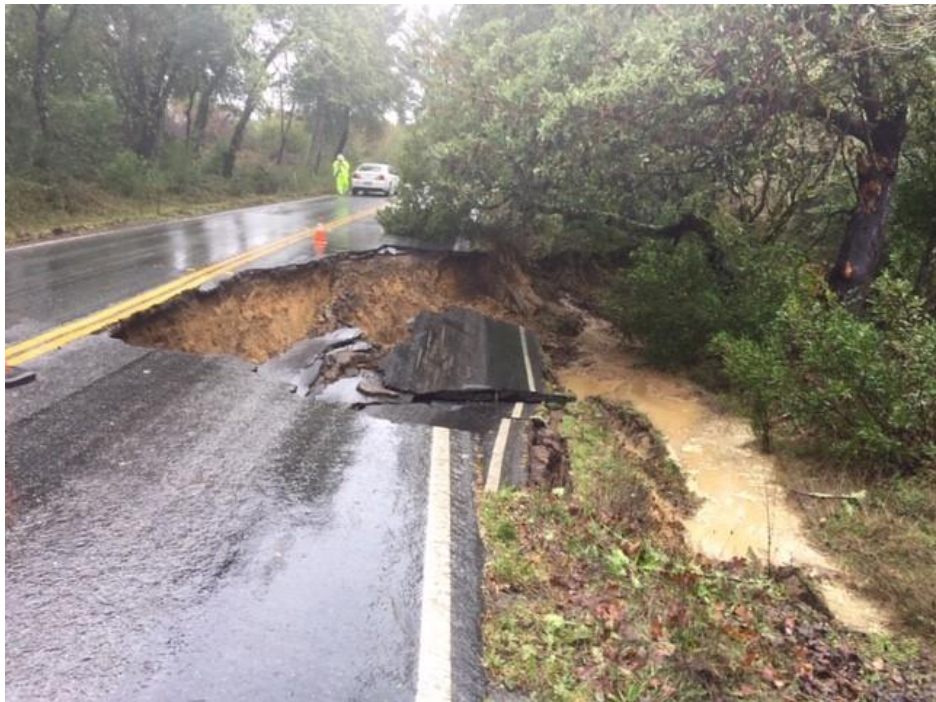
Monday morning, February 4, 2019

2019, noticed subsidence in the pavement and kept an eye on the area throughout the morning. Around noon Caltrans closed the road. By the next day a large sinkhole had swallowed most of the northbound lanes.

Caltrans activated an emergency contractor with Golden Gate Construction, who arrived onsite the following day. Workers began driving sheet piles, interlocking them to form an underground retaining wall that will support the southbound lane.
